Seismic Evaluation and Retrofit Report

**Rancho San Andres Castro Adobe  
Watsonville, California**

Monterey District  
Department of Parks and Recreation  
State of California

May 15, 2003

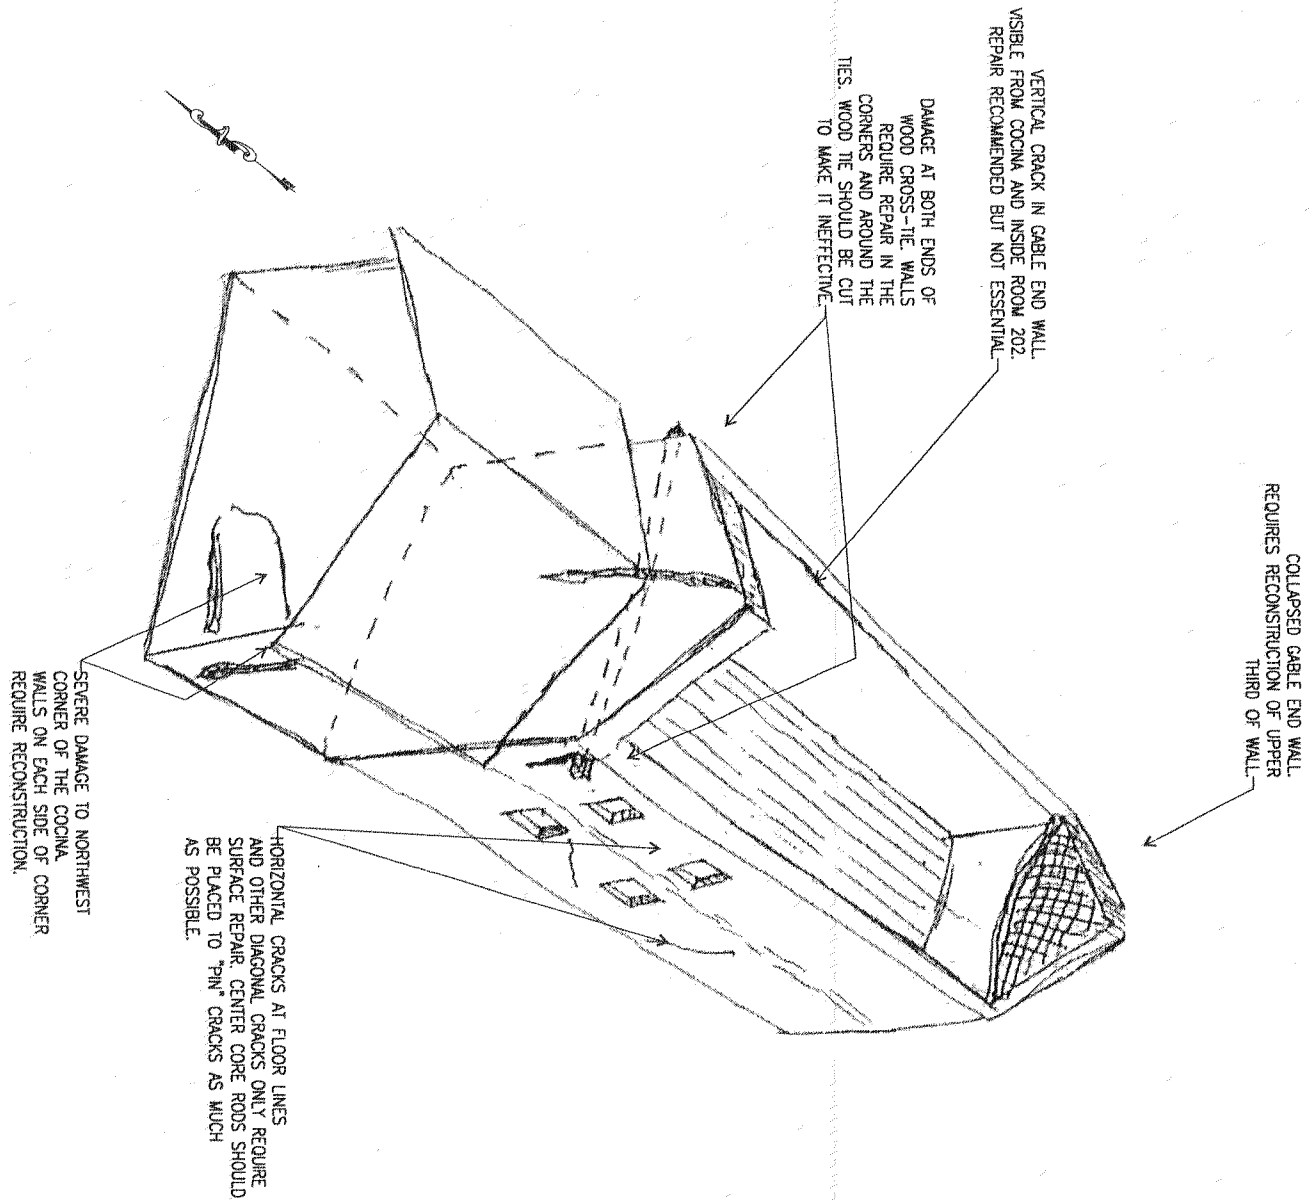
# STRUCTURAL DAMAGE REPAIR SUGGESTIONS

All of the walls of the Castro Adobe have suffered crack damage in all walls of the building. The upper third of the south gable end wall collapsed. The northwest corner of the cocina (Room 101) suffered extensive damage and crack offsets. Significant damage occurred around the transverse cross-tie in the east and west walls above the second floor adjacent to the north gable end wall. In addition, more minor cracking occurred most all adobe walls throughout the building.

There is evidence of previous earthquake damage particularly in the north gable end wall. A photograph of this crack is shown in Detail 3 on Sheet PH1.3. The wood-cross tie in the area was likely installed after this crack developed in the north gable end wall. Unfortunately, the cross-tie results in significant concentrated loads at the end of the cross-tie which as caused damage in the adobe walls at the ends of this cross-tie. To prevent further damage at the ends of the cross-ties, it is recommended that the cross-tie be cut at some location along its length.

The other area of significance is the foundation at the south end of the building. Settlement in this area is apparent from the slope of the first and second floors adjacent to the south gable end wall. This area was underpinned with reinforced concrete piers and grade beams in 1986. Since that time, the underpinning appears to be functioning properly and is no longer a progressive problem. Nevertheless, since the south end of the building has previous settlement problems, it likely makes the south gable end wall more susceptible to earthquake damage in the future compared to the wall before settlement had occurred.

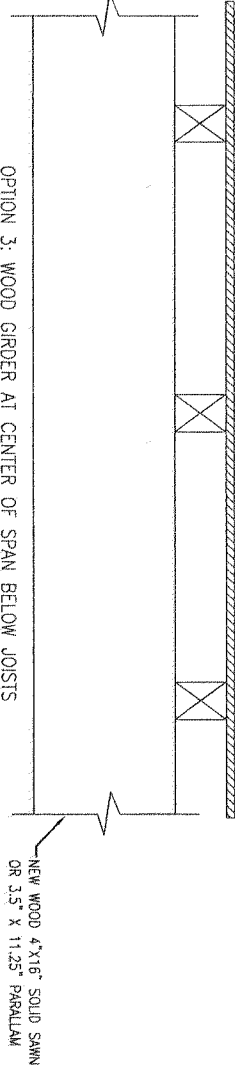
OPTION 3: WOOD GIRDER AT CENTER OF SPAN BELOW JOISTS

The floor framing system that supports the second floor of the San Andres Castro Adobe is very light-weight even by historical standards. The span of 22 feet across the building is larger than typical in residential buildings of this type and era and the depth of the beams of only 5.5 inches is also shallower than typically observed. Therefore, the strength of the floor system is well below current standards.

3. Options 3 and 3A are similar. The use of the large girder down the center of the room would allow sufficient strength and stiffness to be comparable to Options 1 and 2. In option 3A, the girder is raised to match the top height of the existing joists. Option 3A would require cutting each joist at mid-span to make room for inserting the girder. New posts and footing would be required at each end of the girder.
